## DEMAG MANNESMANN VK32 Incident

### A giant chemical industrial plant suffered from failing

**Compressor , gas expander.** The application of this integral geared 4 stage compressor is to supply process air (36.000m<sup>3</sup>/h 1,4 MPa). The driver is a 4,2 Mw electromotor and a fourth stage nitrogen expander turbine.

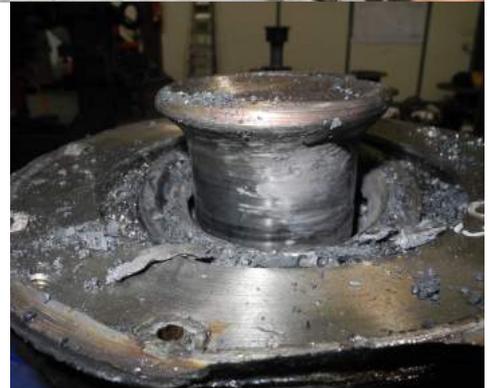
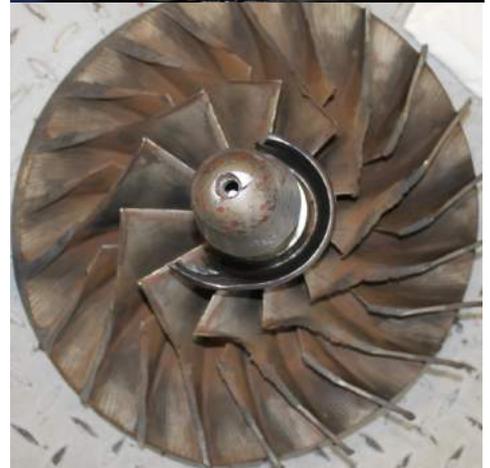
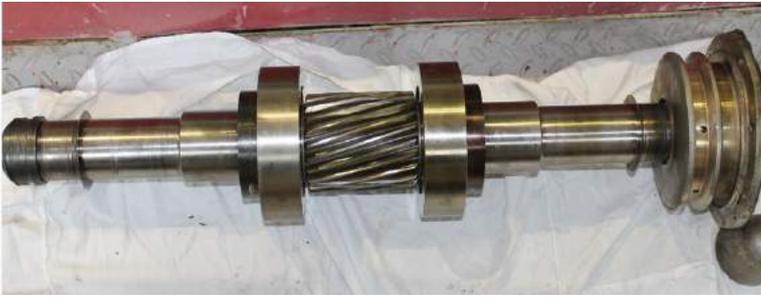
The production stopped immediately, and a first inspection of local technical staff resulted in a determination of completely destroyed impellers and related parts. The damage was enormous, rotor stage 3 & 4 inclusive impellers were completely destroyed. All air labyrinth seals were leaking. Both carbon seals and stuffing boxes were

abraded by friction. Bearings were damaged, some were completely lost.

This resulted in a plan of action where some parts were repaired and others were replaced by parts engineered and delivered by Energetic nv.

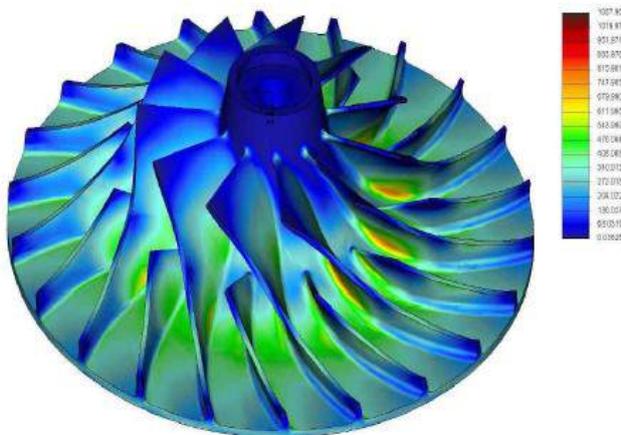
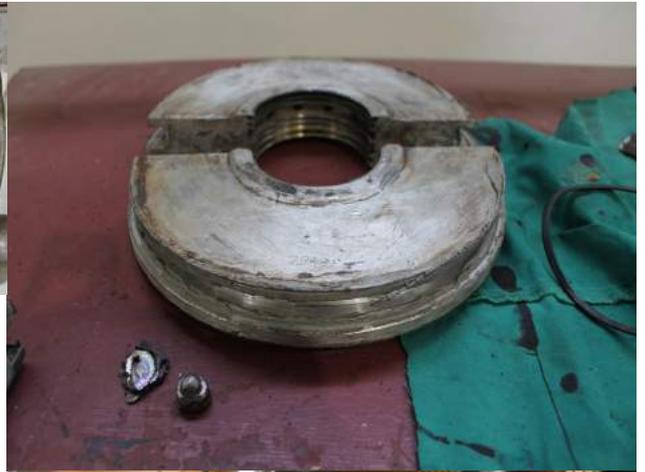
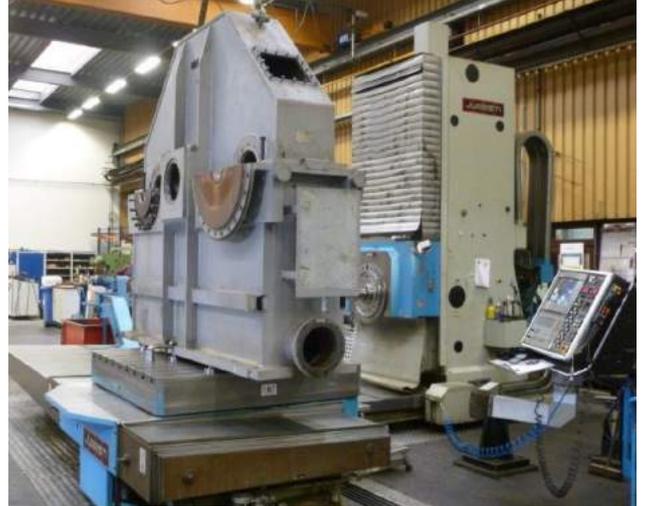
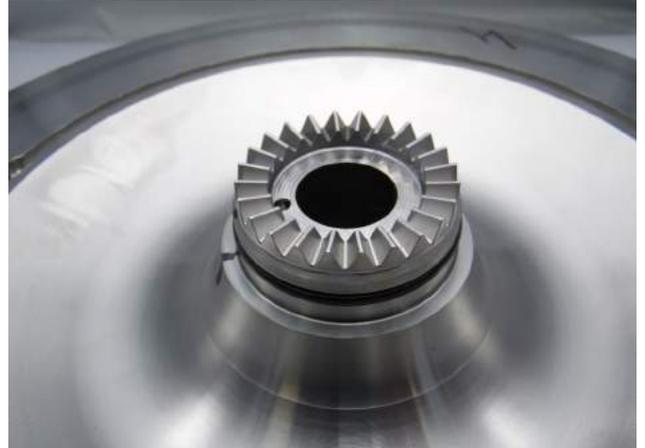
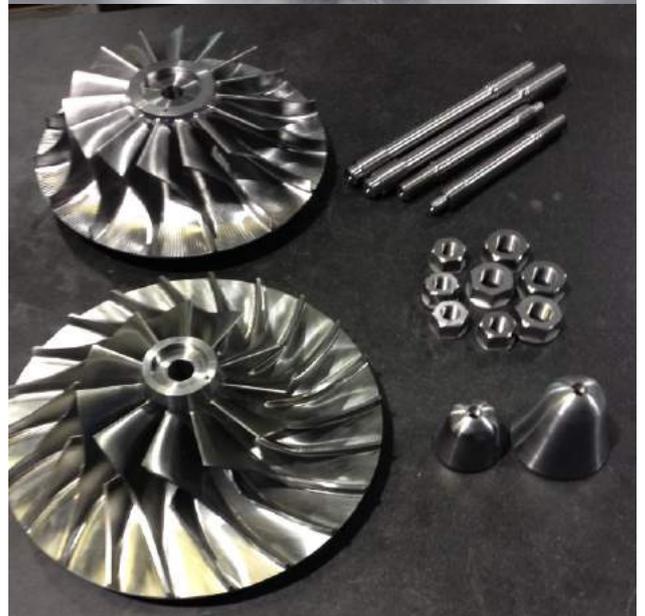
It was clear from the beginning that the Pinion stage 3 & 4 needed to be reproduced. The pinion stage 1 & 2 and the bull gear where part of an geometric inspection , which resulted also in a new manufacturing pinion and bull gear re-grinding. In fact the two new pinions where modeled towards the grinding result of the bull gear. The aim was to transfer load with minimum of noise and vibrations

The existing impellers were not useable as model for reproduction, Therefore a complete thermodynamic calculation was executed, inclusive CAD remodeling by using Siemens NX, to meet minimum the required performance.

The manufacturing was quality guided by following the API standards, inclusive spin and over speed tests

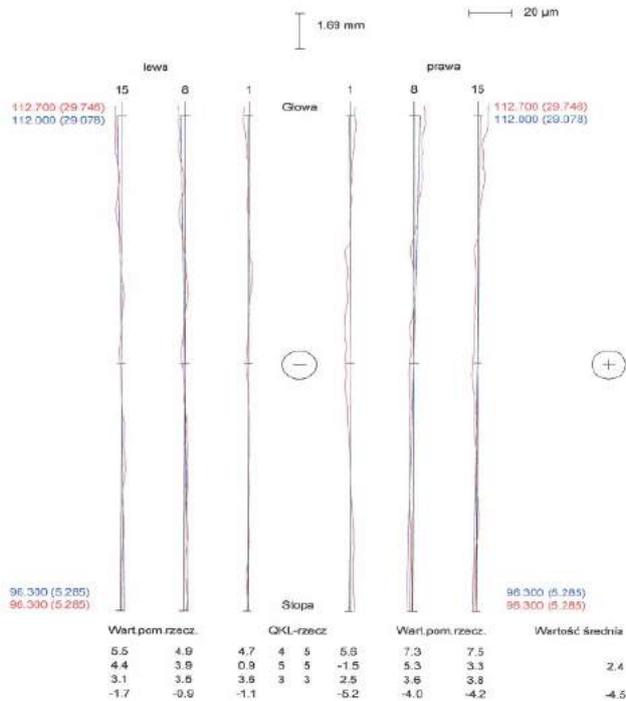
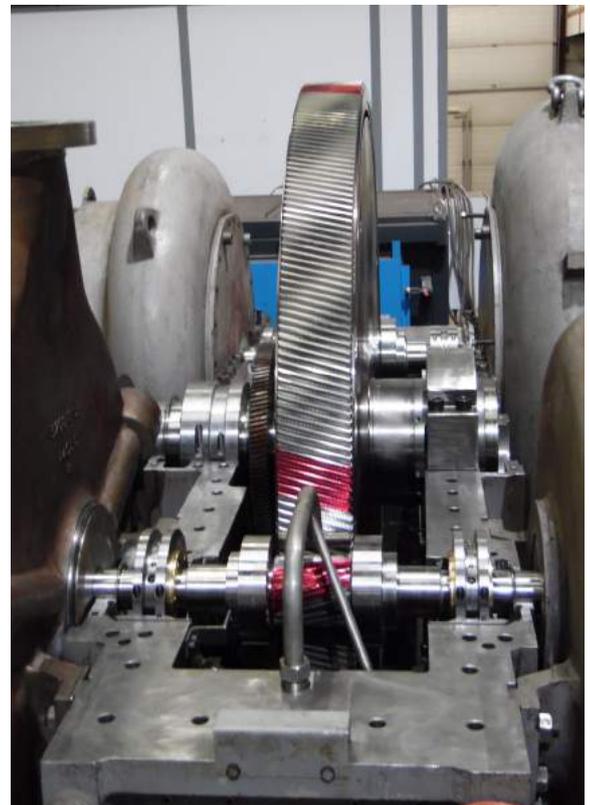
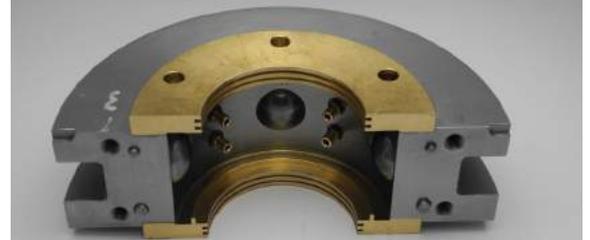
The primer inlet I.G.V's where complete maintained , the gas expander inlet guide vanes where renewed by engineering and modeling because of deformation caused by the impeller rub.

The bearings from bull gear, radial and axial /radial where re-babbited. The existing tilting pad bearings where replaced by a special design which allows the pad to tilt in multiple directions, with a better guidance during shaft rotation under load and specially during start up. The new pinions where degaussed and the electrical run out was checked, after completing the burnish activity on the probe surface .
