Major revamp of a Sulzer G90/4a EK Brown Boveri

Salt factory goes for proven technology

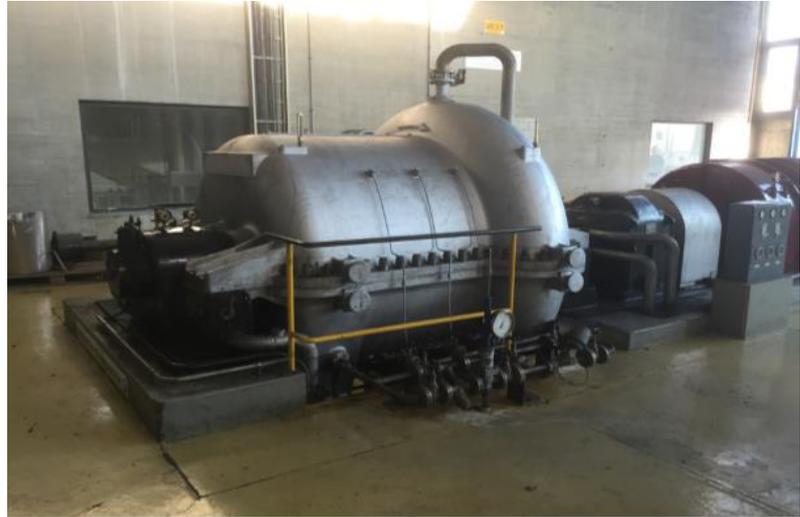
and the compressor housing. This results in all kinds of damage, such as deformation of the internal body parts, resulting in leaks and steam reflow. These phenomena badly affect the compressor's uptime and efficiency and could even lead to complete standstill. In that case the factory cannot dry any more salt since this installation is crucial to the production process.

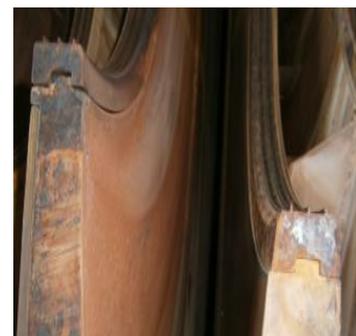
When some years ago the Sulzer G90/4a EK steam circulating multistage compressor in one of the sites came to a halt, the salt producer decided to invest in a new integral geared compressor; unfortunately causing more worry than benefits. On the one hand, the plant was forced to remain at standstill for quite some time, while the system was being installed. On the other hand, the new technology proved to be significantly less resistant to the specific environmental context and variability in process parameters (pressure,

flow and temperature changes), which required extra investments in adjustments to stabilize the production process. When the Sulzer compressor in the second plant also started to show problems, the salt factory was anything but keen to replace this compressor by a new one as well.”

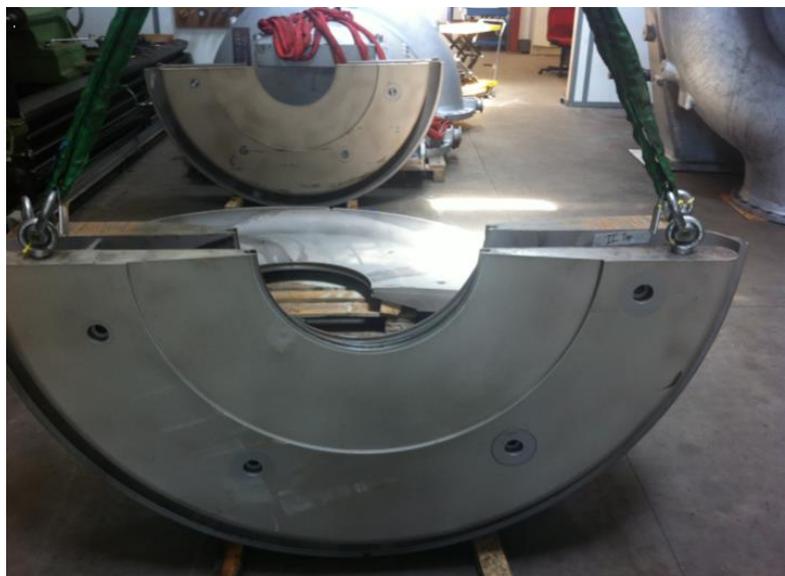
Energetic disassembled the old compressor and transferred the parts to the Stekene workshop. All parts were inspected for cracks, conform the ISO 3452 standard. The use of replicas allowed to investigate the structure of the material in terms of usability. The installation turned out to indeed be on its last legs, with the diaphragms being eroded and corroded to such extent they had become unusable. The diaphragms' centreline also no longer corresponded with the rotor axis and the labyrinths were complete worn out by corrosion and friction, all with huge losses in efficiency as result. Lastly, corrosion was detected on the split line between the compressor top and bottom casing. The stuffing boxes also had become obsolete, since the casing's seats were totally eaten away by corrosion, as were the compressor casings, totally deformed by significant corrosion between the housing and internal bodywork. Both top and bottom had been affected also, making it no longer possible to calculate the dimensions for the installation of the internal parts, such as

the diaphragms. Finally, the plain bearings, oil labyrinths and threaded connections only could be scrapped.
