# SST300 steam turbine overhaul and repair

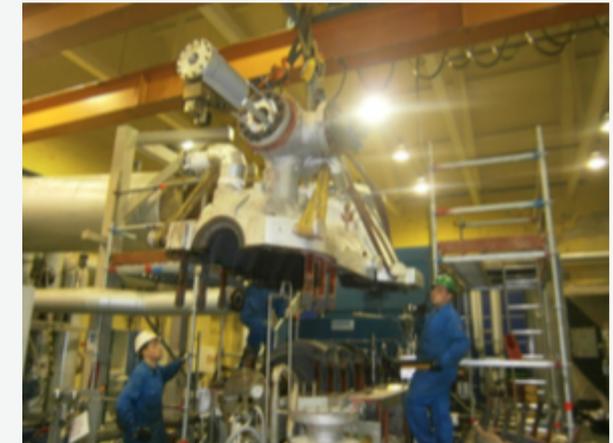
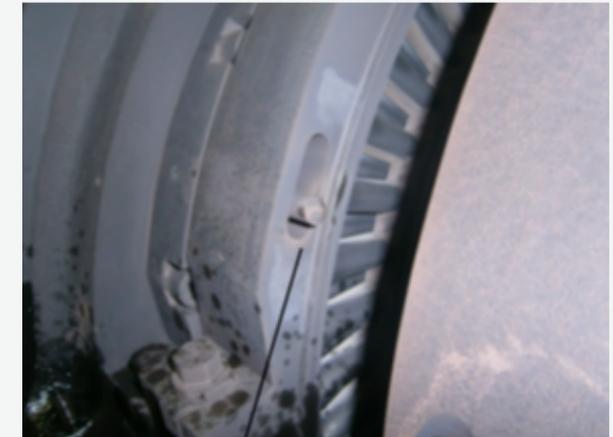
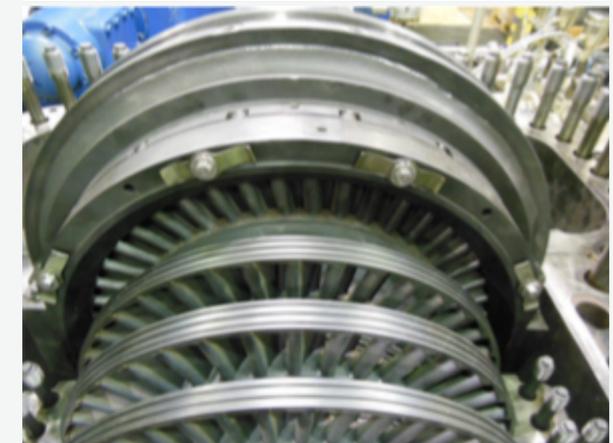
Energetic was shortly after ordered to proceed with the inspection and the turbine was opened. Inside we found that bolts and bolt springs was damaged and had broken off. The reason for this is because of sudden expansion of steam during commissioning or shut down. Slamming the guide vanes causing the bolts to brake. This later escalated the damages on several positions.

The rotor was also found damaged at the first stage seal strips. Energetic shipped the rotor and damaged parts to Stekene for repair. Seal strips was replaced in the workshop and reverse engineering was done on the bolts and springs in order to be replaced. A material scanning was also made to see if improvements could be implemented on that aspect. That theory was true and the new parts was produced in a stronger material.

The parts came back after 1 week in the shop and was assembled, with a total down time of 3 weeks the turbine was started back up again with stable and safe vibration levels also at higher loads.
