## DEMAG MANNESMANN VK32 Incident

### A giant chemical industrial plant suffered from failing

**Compressor , gas expander.** The application of this integral geared 4 stage compressor is to supply process air (36.000m<sup>3</sup>/h 1,4 MPa). The driver is a 4,2 Mw electromotor and a fourth stage nitrogen expander turbine.

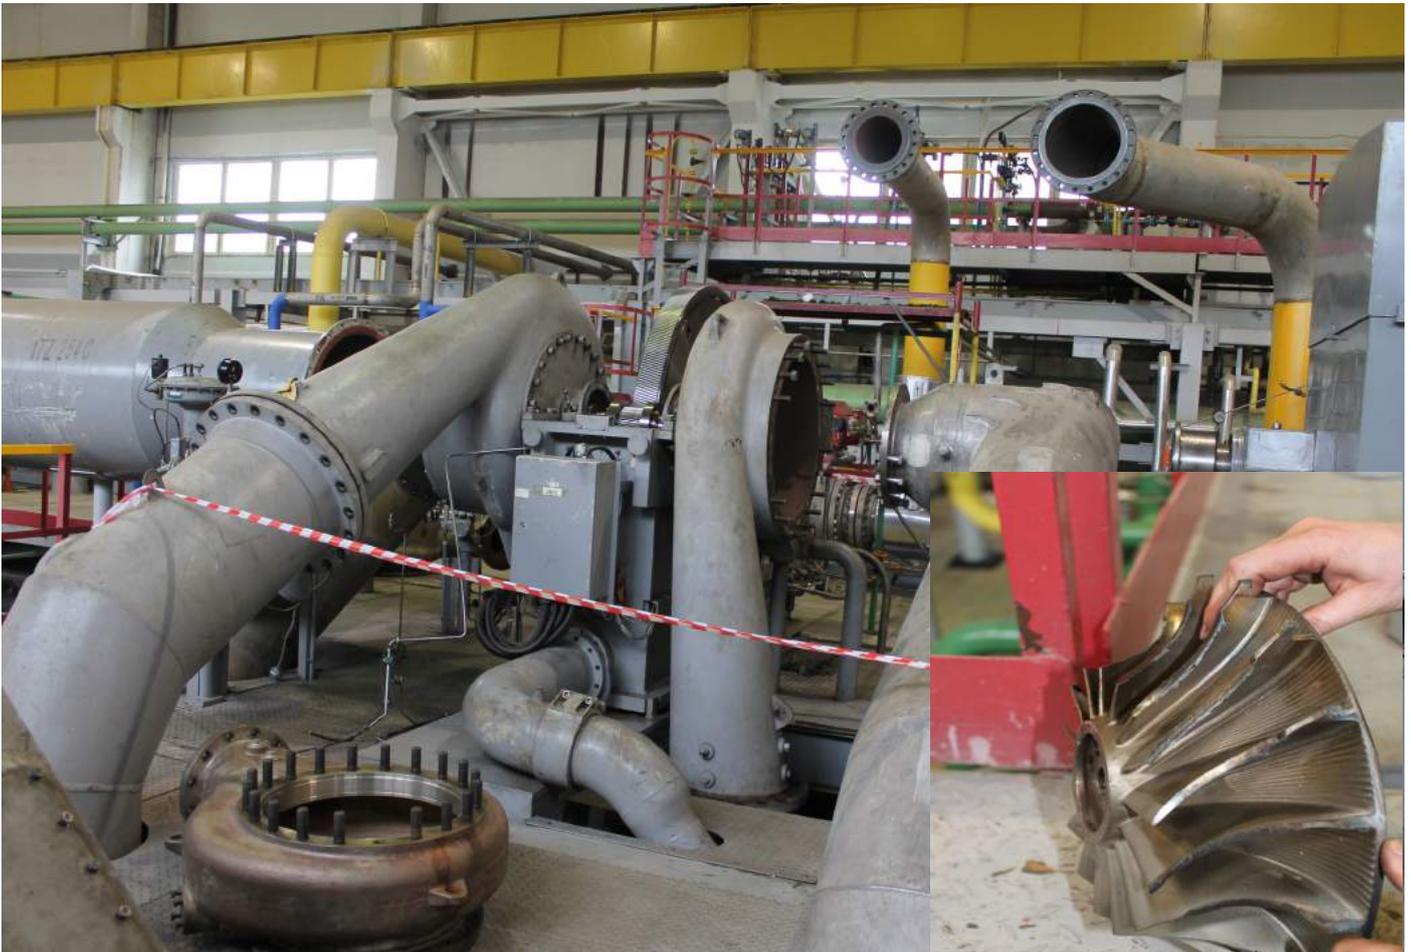
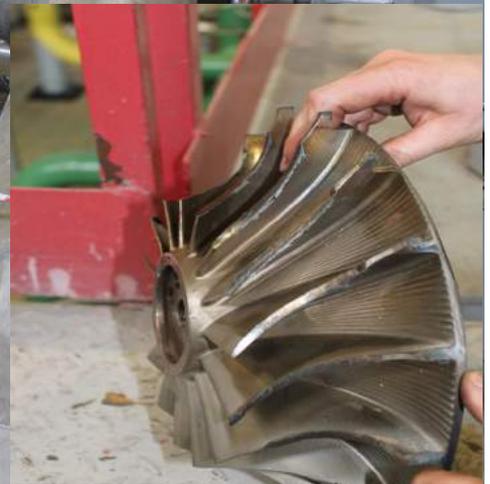
An incident caused an important impeller rub with big consequences as result.

The production stopped immediately, and a first inspection of local technical staff resulted in a determination of completely destroyed impellers and related parts. The damage was enormous, rotor stage 3 & 4 inclusive impellers were completely destroyed. All air labyrinth seals were leaking. Both carbon seals and stuffing boxes were

abraded by friction. Bearings were damaged, some were completely lost.

The complete compressor was dismantled from base plate and transported to the workshop of Energetic NV in order to start a more detailed inspection.
