SST600 Steam turbine overhaul and repair

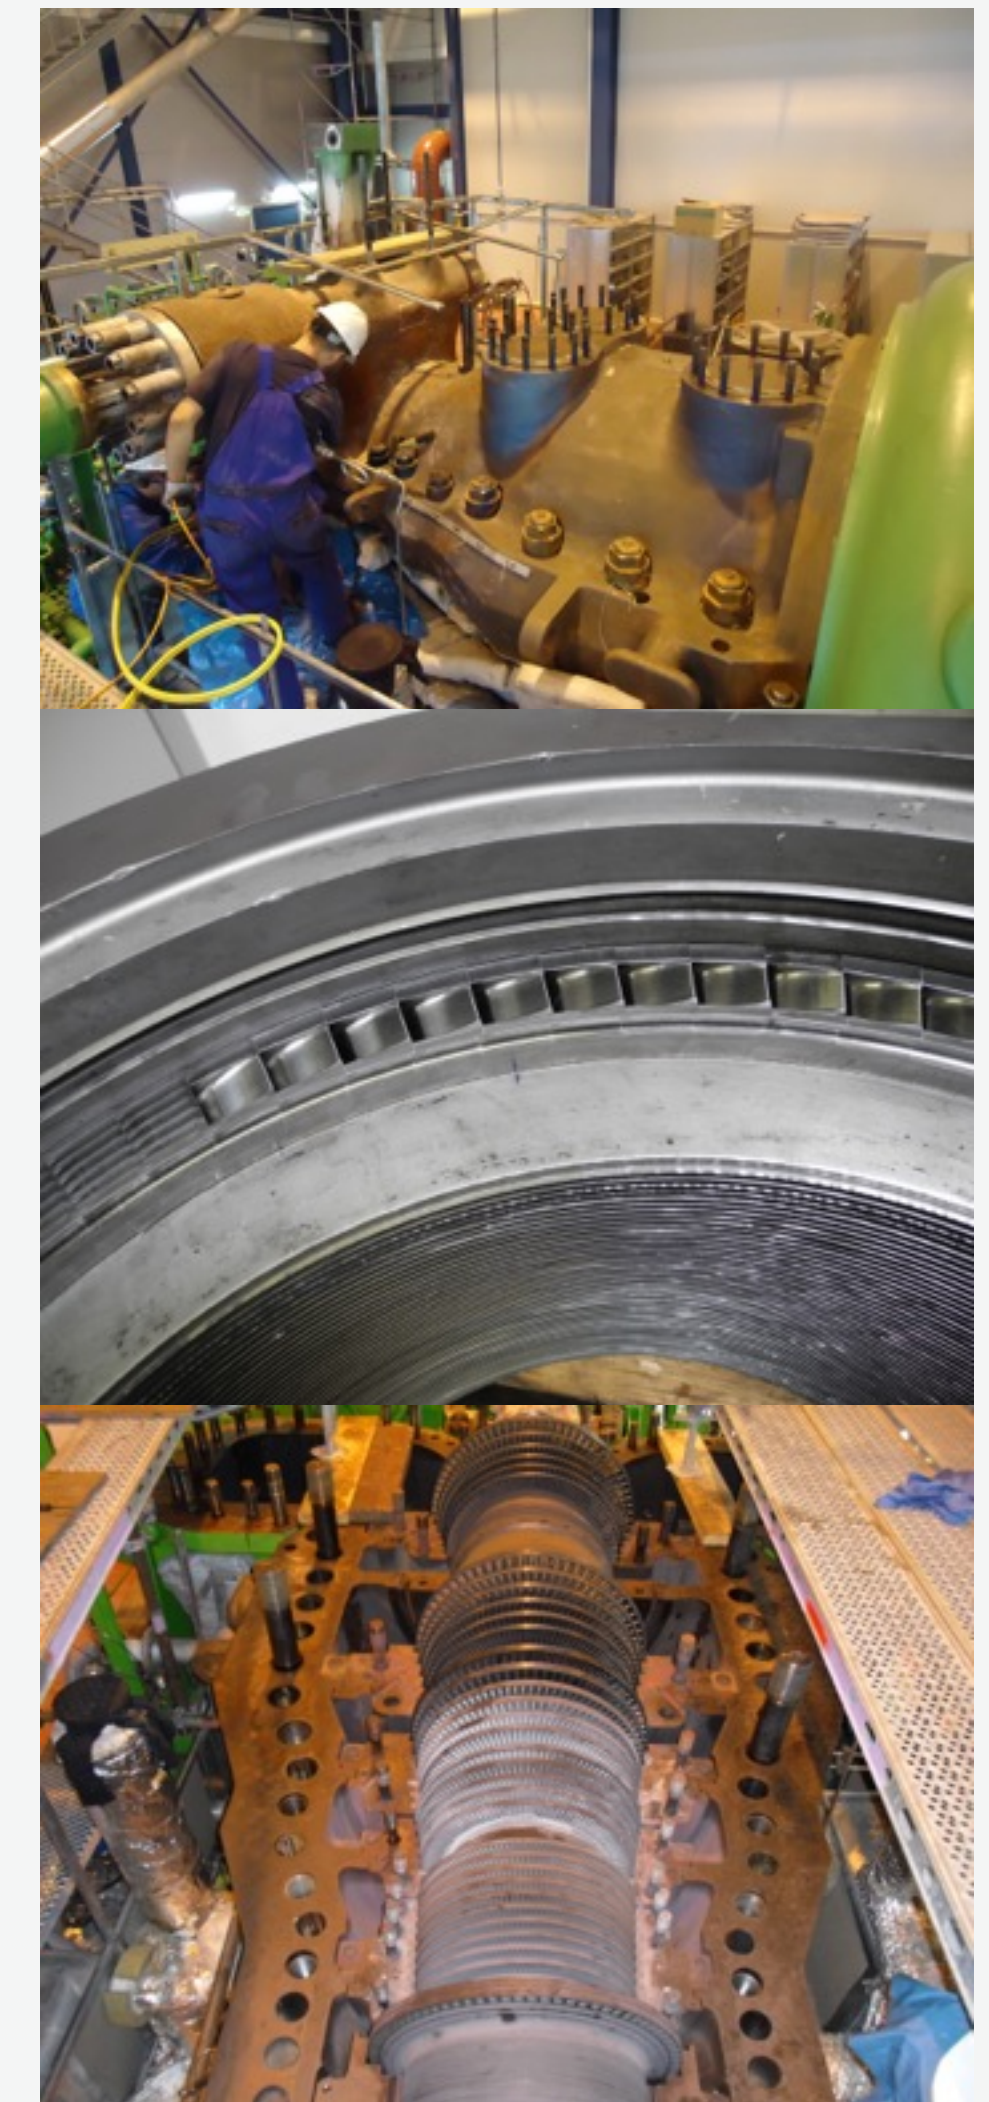
A power plant, biomass CHP with a SST-600 steam turbine with condensing function for district heating - was in need of repair work after discoveries made during a turbine overhaul. It was while performing the annual borescope inspection when Energetic technicians discovered impacts on the rotor, seals and nozzles. A quick decision was made together with the customer to open the machine and investigate further the extent of the damages. It was concluded that the machine suffered from foreign object damage.

The rotor together with static parts was urgently shipped to the Energetic workshop in Stekene for refurbishment. Glass blasting of the rotor was made in order to inspect further. Inspections later showed that no cracks had developed from the impacts, making it possible to grind and polish to prevent the development of cracks in the future. A relatively less-cost solution. But the turbine was in need of extensive seal strip replacement due to the foreign objects travelling around in the steam path. Nozzles was also in the need of replacement.

Energetic was able to recover some of the foreign object material. And material analyze revealed the origin of the part. Locking pins from the control valve housing. Not safely secured during installation.

Later the machine was since years also suffering from steam leakage at the control valve spindles. A normal switch to new spindles and packing box parts did only solve the problem for about 2 months. Energetic was assigned to come with design modifications to cure this problem and keep the steam leakage away. In 2016 a new valve beam and spindle design was installed.
